ANNANDALE MIDDLE SCHOOL FACILITY ANALYSIS

Annandale, Minnesota

Independent School District No. 876

Project No. 97033

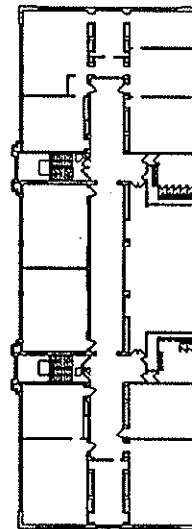
ABANDONED
THIRD LEVEL

Gross Area: 150,827 S.F. (includes 12,224 SF of
abandoned 3rd floor)
